# Dean Forest Railway Telecoms

**Norchard DP3UA (Lockable Plastic Joint at Ground Level)**

**Location : 200m north of Upper Forge Access**

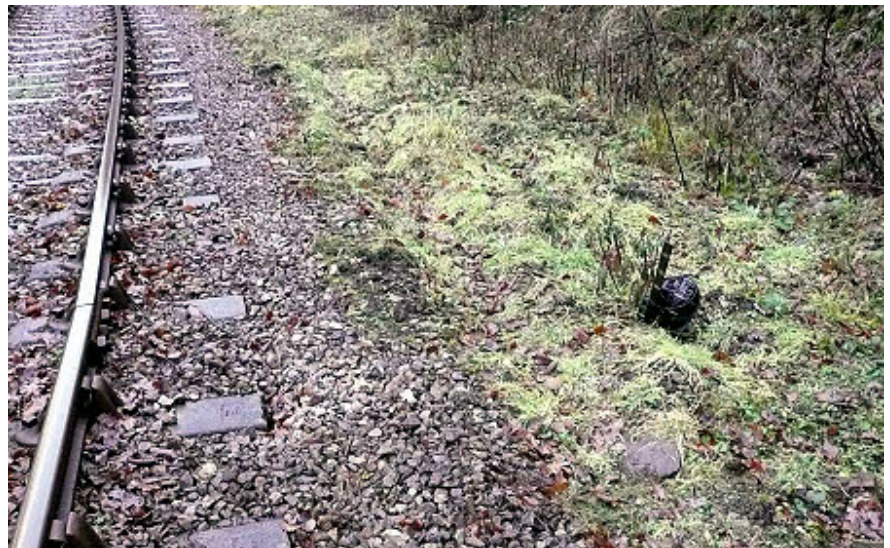
**Safety Category : Type 2 safe with care**

**Distance from rail : 2m**

**Hazards :** Rough ground on approach which can also be very overgrown if the scrub has not been cut down recently. Joint is a cable repair and is located at ground level. It is not marked in any obvious way and care must be taken if strimming or flailing in the area. Work is needed to improve the visibility of this joint. Limited visibility of approaching trains.

**Special Precautions Required : A minimum of two men must go to site, as site is a possible nasty falling and tripping area and technician can be invisible to public.**
