Dean Forest Railway Telecoms

Parkend DP1E

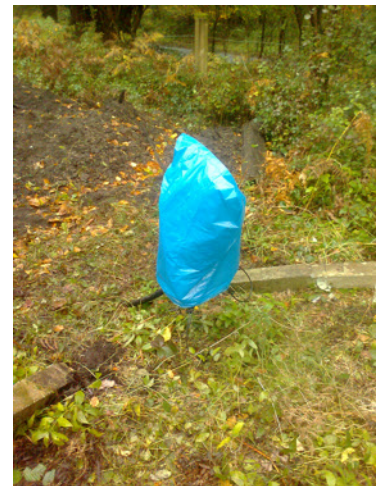
Damaged Joint in Plastic Bag, this a temporary situation

Location : 75m south of Oakenwood no 3 Crossing

Safety Category : Type 2 safe with care

Hazards : Rough ground on approach.
