Dean Forest Railway Telecoms

Norchard DP3V (Small Cabinet on post)

Location :300m south of Tufts Bridge

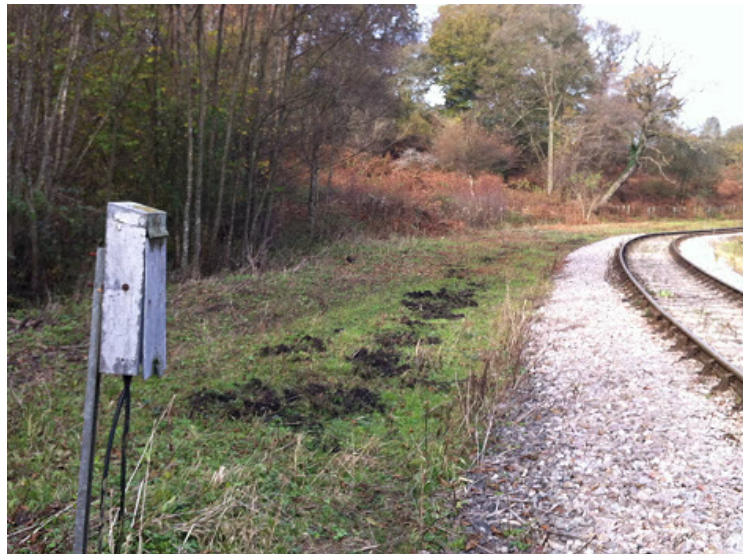
Safety Category : Type 2 safe with care

Distance from rail : 3m

Distance from rail by Technician : 2m

Train visibility : South 100m, North 100m

Hazards : Rough ground on approach which can also be very overgrown if the scrub has not been cut down recently. Beware the possibility of wasps nest in cabinet. Cabinet can be easily hidden in very high lineside growth. Limited visibility of approaching trains.

Special Precautions Required : A minimum of two men must go to site, as site is a possible nasty falling and tripping area and technician can be invisible to public.
